SMALL ARMS RANGE TRAINING AREA ENVIRONMENTAL SCREENING-LEVEL ASSESSMENT AT FORT JACKSON, SOUTH CAROLINA

SITE LOCATION: FORT JACKSON, SOUTH CAROLINA

PREPARED BY: U.S. ARMY ABERDEEN TEST CENTER ABERDEEN PROVING GROUND, MD 21005-5059

March 2005

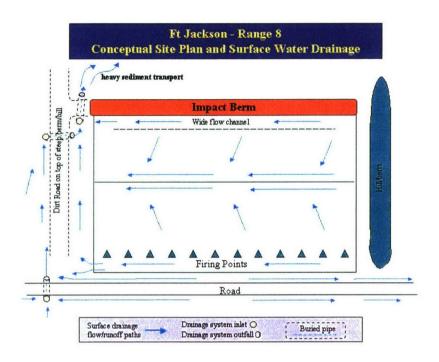
Figure 7-1. Range 8, Existing Drainage.

Ranges 8 and 9: The stormwater runoff from both of these ranges currently flows to the same general area behind the impact berms on Ranges 7 and 8, eventually discharging into Rowell Creek behind Range 7. A distinct drainage channel was noted in the wooded area behind Range 8. In an effort to improve stormwater runoff quality by reducing sediment transport, it is recommended that the drainage area behind Range 8 be examined for possible installation of a stormwater detention pond (or other management structures/efforts) to help manage the runoff waters from Ranges 8 and 9. This area is shown in Figure 7-5.

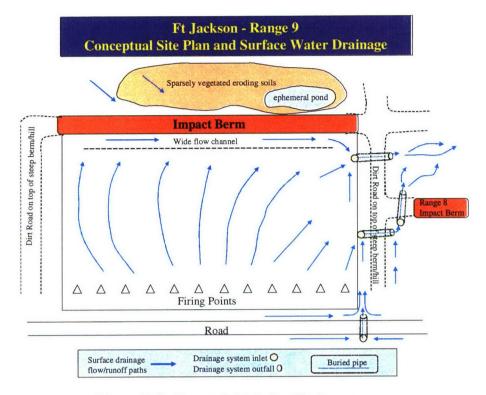
Figure 7-3. Range 9, Existing Drainage.

There is an area of seasonal standing water behind the impact berm on Range 9. This pond appears to have been formed by the construction of the berms serving as roads in this area (Figure 7-3). The berms have cutoff the natural surface drainage patterns trapping runoff water. This area is a direct impact zone for Range 9. A large amount of bullets and fragments are clearly visible on the ground surface as a result of rounds being fired over the berm. The pond in this area creates conditions very conducive to the dissolution of lead from bullet fragments. The water in this pond was not sampled but it may have an elevated lead concentration based on the

site conditions. There was also evidence that the water is being used by wildlife. Combining the lead dissolution and wildlife use issues, it is recommended that alterations be performed in this area that will allow surface water in the area to drain and eliminate the seasonal pond. This recommended alteration is shown in Figure 7-4.
